Inspection Report

Sample Report

Property Address:
115 Maple Ct SW
Hiram GA 30048

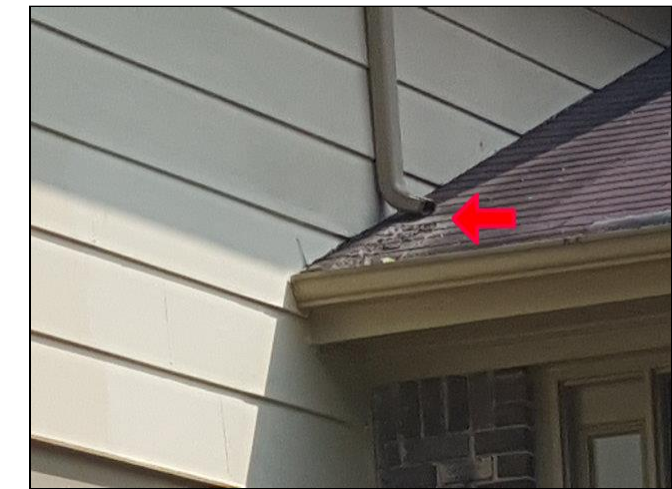
1.0 Item 1(Picture) Damage

1.0 Shingle damage at front entrance at downspout, recommend repair by a qualified roofing contractor.

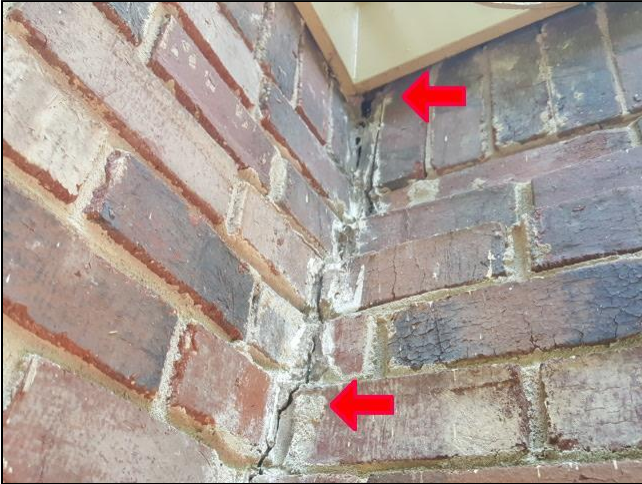
1.2 Item 1(Picture) Settling

1.2 Noted settling at brick chimney. Previous repairs made but additional settling may have occurred. Recommend evaluation by a qualified foundation technician/engineer.

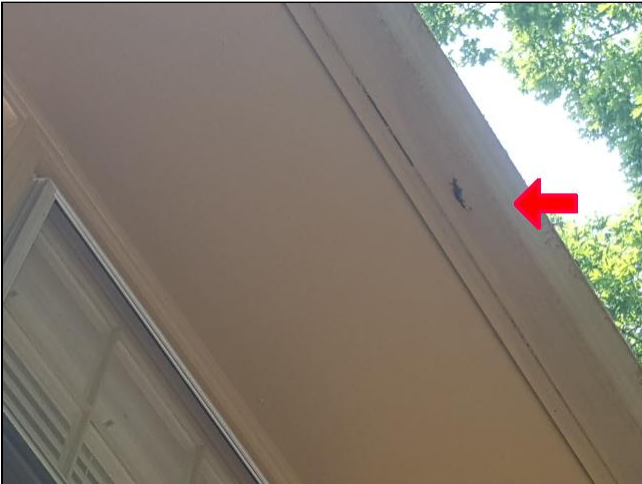
1.3 Item 1(Picture) Rust

1.3 Noted rust at left side gutters, recommend repair by a qualified contractor.

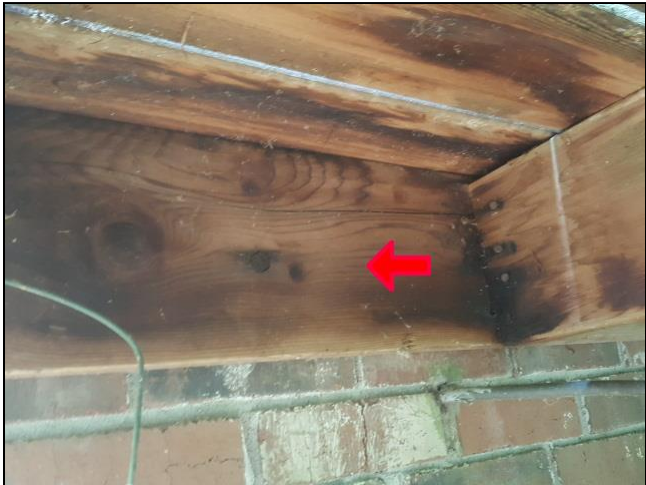
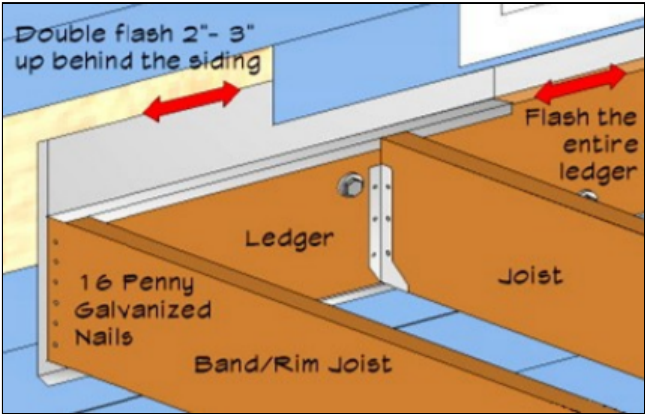
2.3 Item 1(Picture) Attachment

2.3 (1) Perhaps not required when the house was built but today, newer safety measures have been implemented for fall safety purposes. The deck band is not attached properly to the wall or band of the home. It should have 5/8 galvanized "Lag Screws" or "Carriage Bolts" approximately every 36 inches. Recommend repair by a qualified contractor.

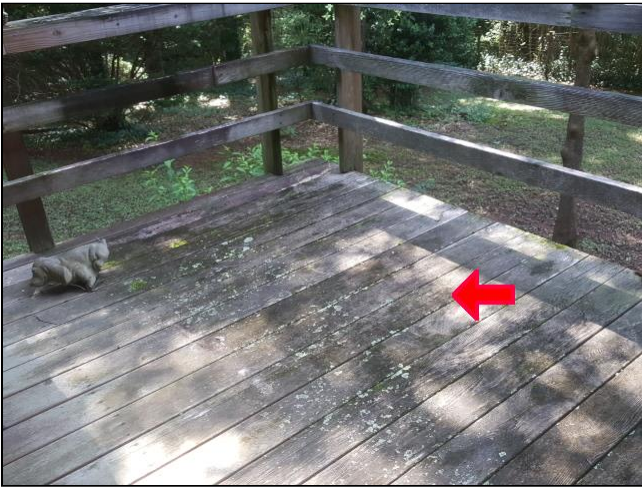
2.3 Item 3(Picture) Weathered

(2) Deck has weathered significantly, recommend sealing/repair by a qualified contractor.

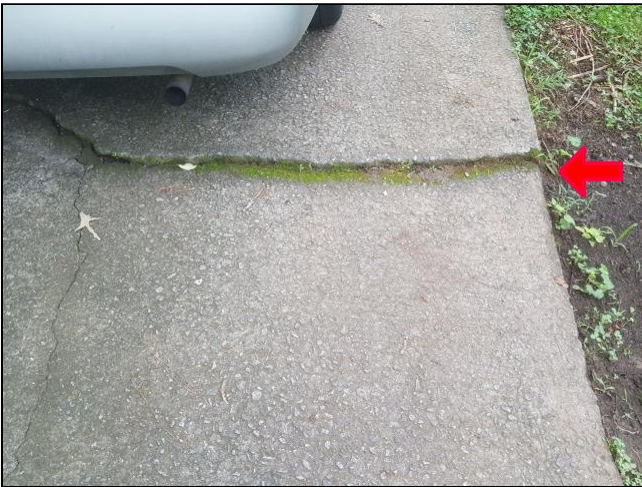
2.4 Item 1(Picture) Cracks

2.4 (1) Cracking noted at driveway-trip hazard; repair as required.

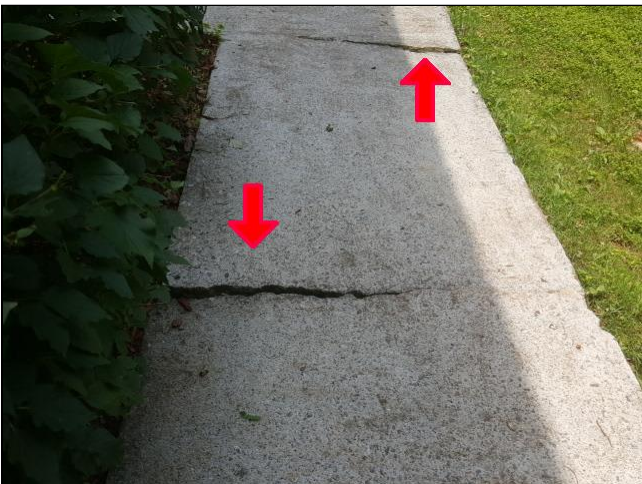
2.4 Item 2(Picture) Crack

(2) Cracking noted at walkway-trip hazard; repair as required.

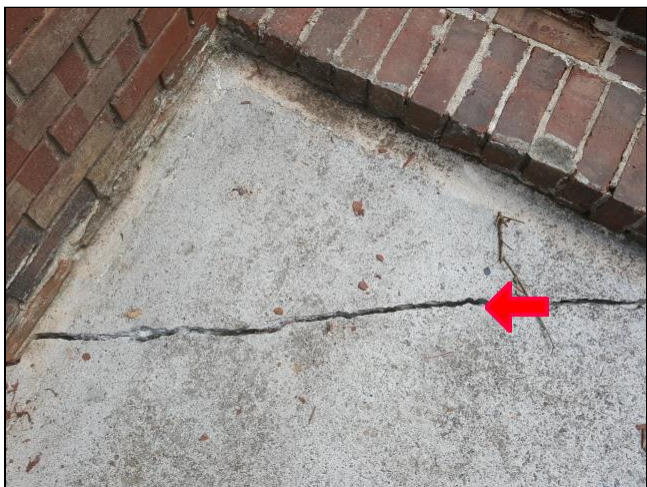
2.4 Item 3(Picture) Settling

(3) Settling at front entrance sidewalk, recommend repair by a qualified contractor

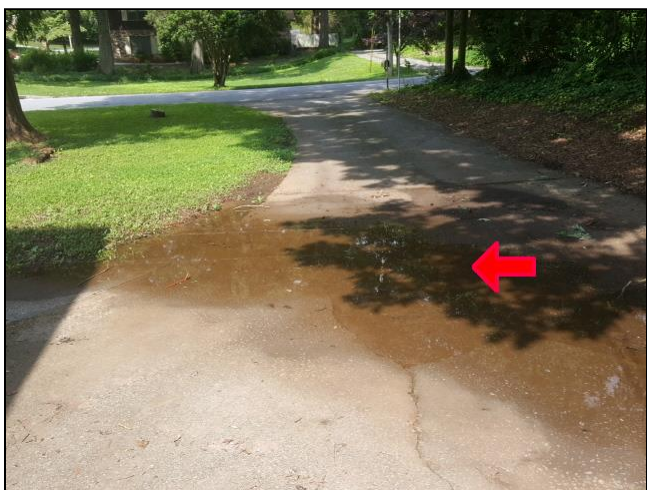
2.4 Item 4(Picture) Ponding

(4) Water ponding at driveway, recommend repair by a qualified contractor to prolong life of the concrete.

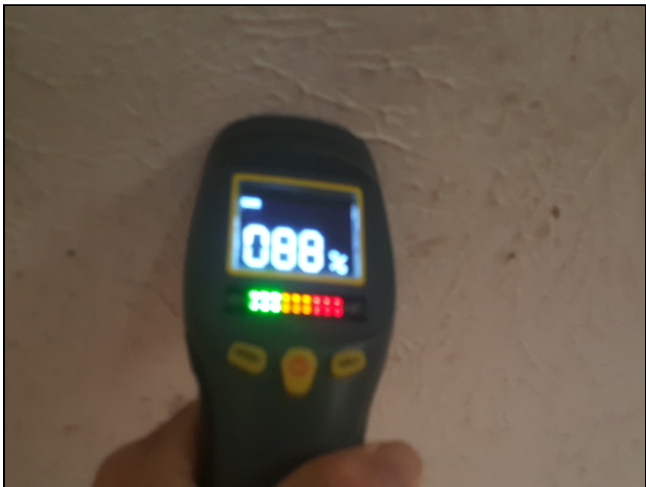
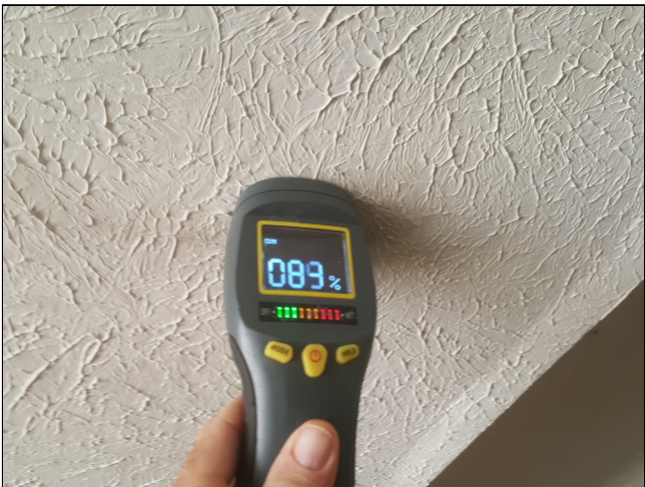
3.0 Item 1(Picture) Excessive Moisture

3.0 Excessive moisture can indicate a leak, recommend repair by a qualified plumbing contractor

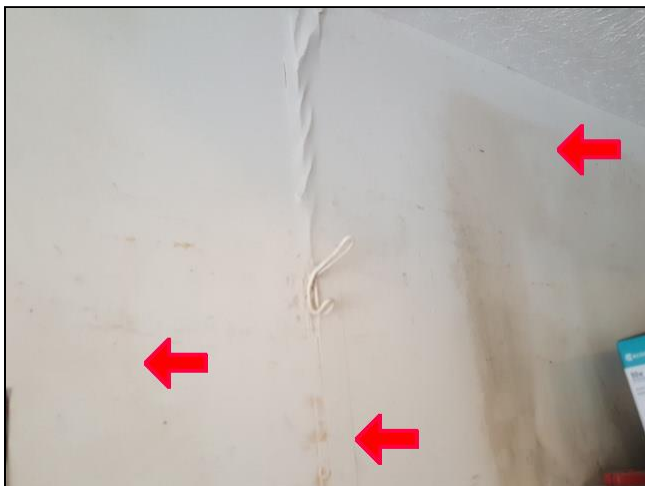
3.1 Item 1(Picture) Discoloration

3.1 Discoloration noted at garage walls, no mold sampling was done in this scope of work, recommend repair by a qualified mold/mildew contractor

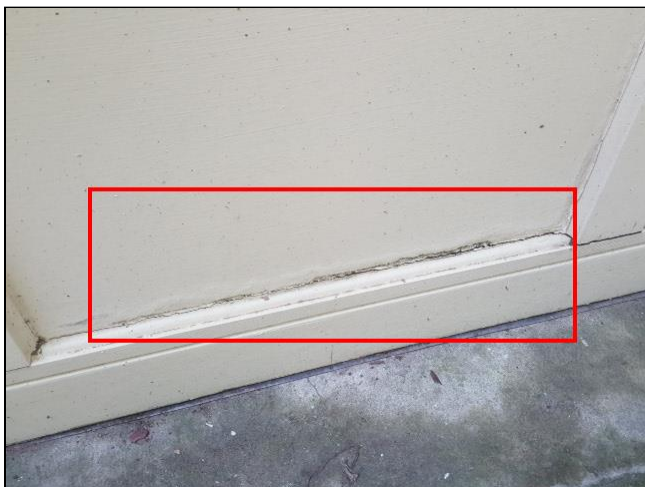
3.3 Item 1(Picture) Moisture Damage

3.3 Noted moisture damage along bottom panel of garage door, recommend repair by a qualified garage door contractor.

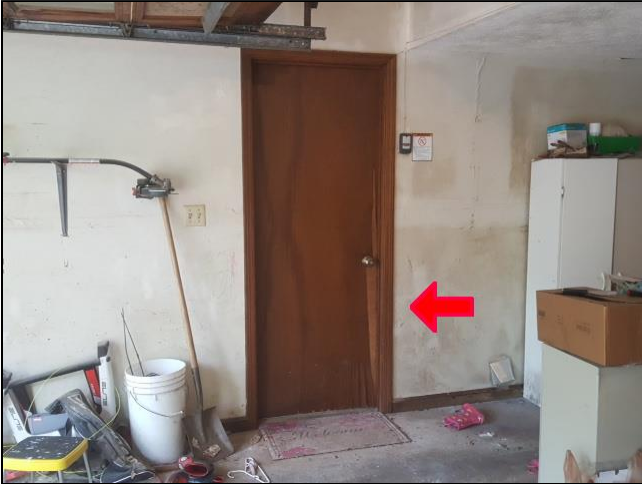
3.4 Item 1(Picture) Not Fire Rated

3.4 The occupant door from inside garage to inside the home is not a fire rated door. This means that should a fire occur in garage, the occupant door does not afford protection until fireman arrive. This door should be replaced with a fire rated door.

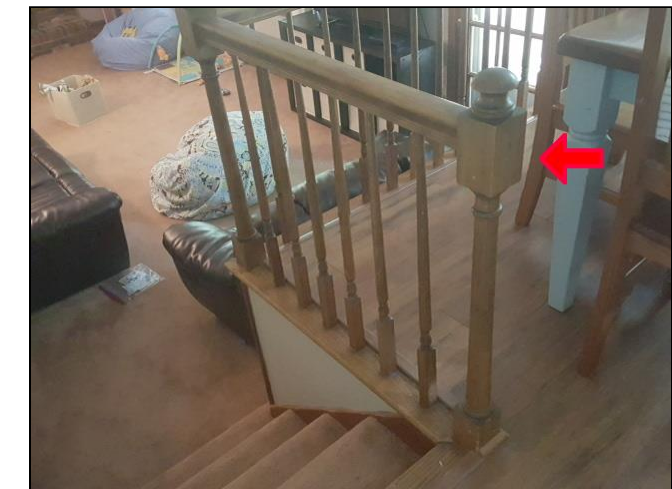
4.3 Item 1(Picture) Loose

4.3 Loose handrail at main level, recommend repair by a qualified contractor

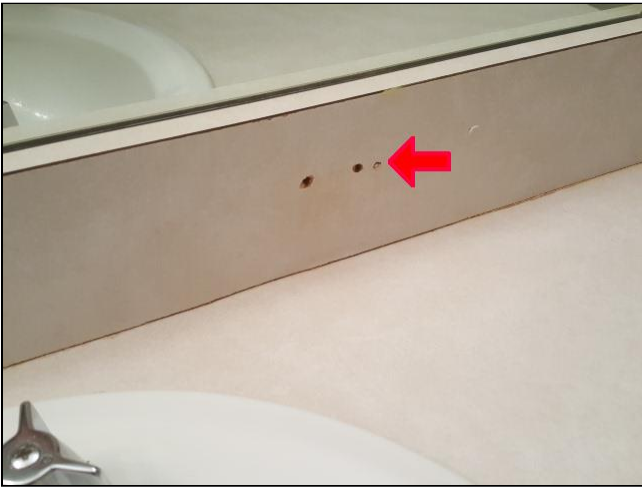
4.4 Item 1(Picture) Damage Main/Upper

4.4 Damage at counter at main level/upper level bathroom

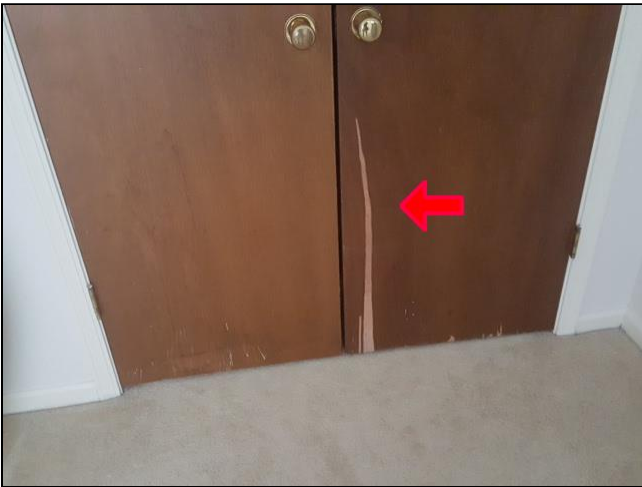
4.5 Item 1(Picture) Damage

4.5 Surface damage at front bedroom door, recommend repair as desired

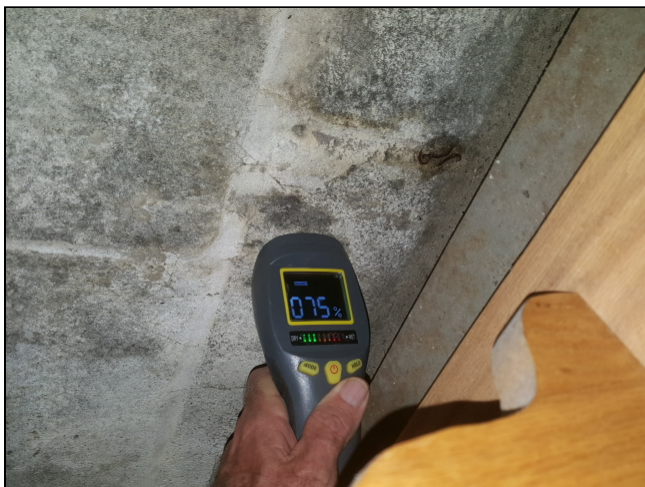
5.0 Item 1(Picture) Elevated Moisture (75%)

5.0 (1) White efflorescence (powder substance) on block wall indicates moisture is in contact with the masonry. This does not necessarily indicate that intrusion will occur. Recommend checking the gutters and the downspout drain lines for proper operation. Also, a water proofing paint could be applied to the interior side of the block if necessary. Efflorescence is found on many homes without water intrusion occurring inside the home. But, it should alert you to the possibility that future steps may be needed.

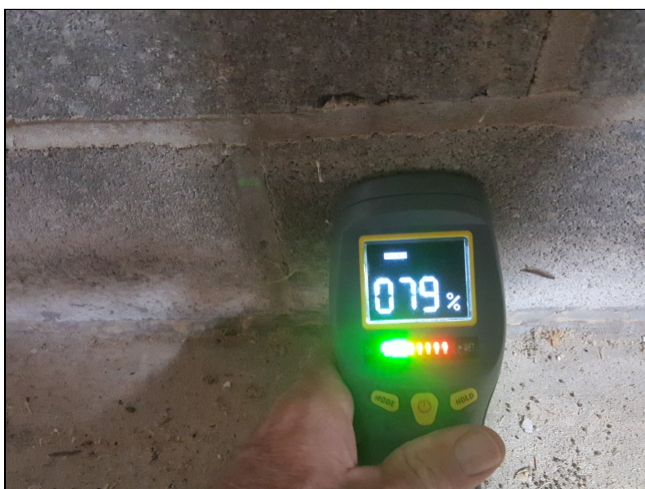
5.0 Item 2(Picture) Elevated Moisture (79%)

(2) Excessive moisture at rear masonry wall, recommend repair by a qualified plumbing contractor

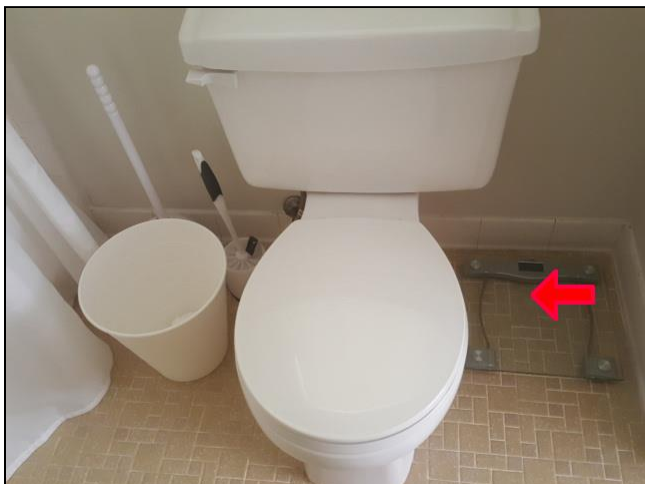
6.0 Item 1(Picture) Loose

6.0 The toilet is loose at floor at the main level bath. Repairs may involve re-setting the toilet on a new wax seal. I recommend a qualified licensed plumber repair or correct as needed.

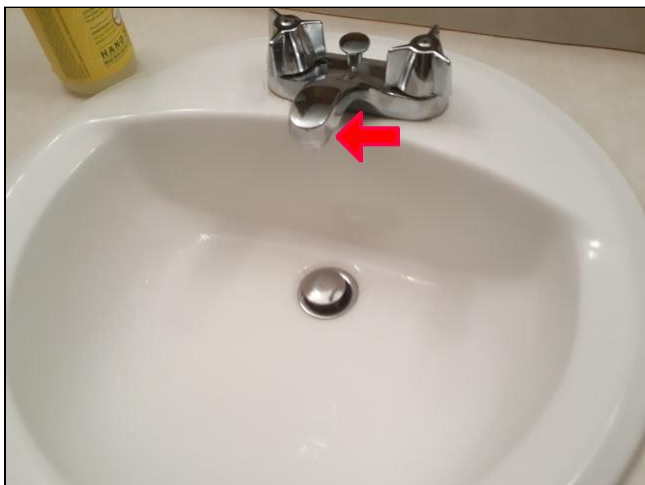
6.1 Item 1(Picture) Valve Leak

6.1 (1) Main level bathroom faucet leaks, recommend repair by a qualified plumbing contractor

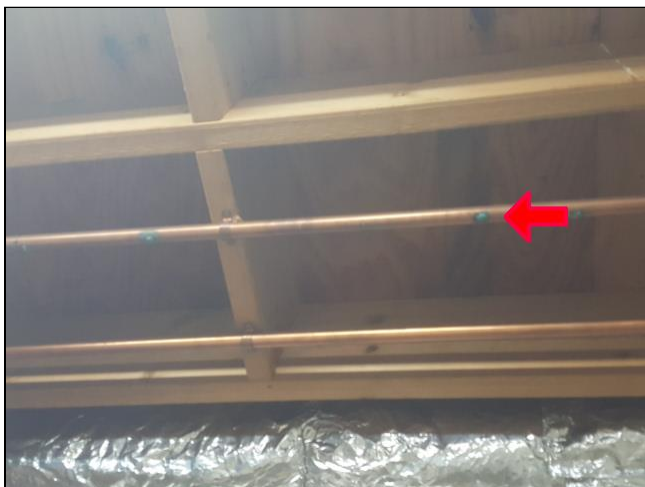
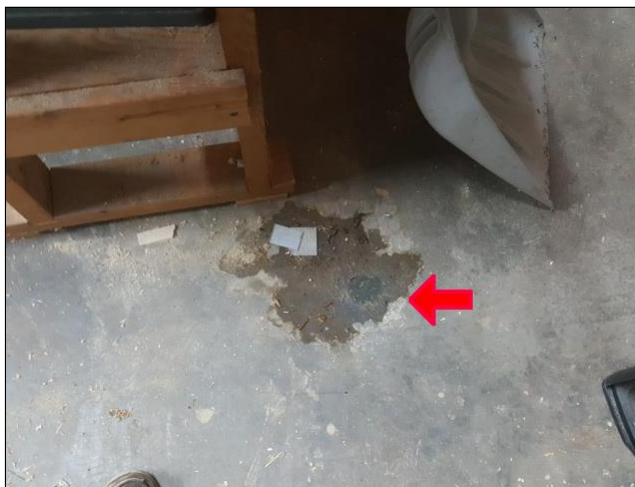
6.1 Item 2(Picture) Leak

(2) Pinhole leak at water supply at basement, recommend repair by a qualified plumbing contractor

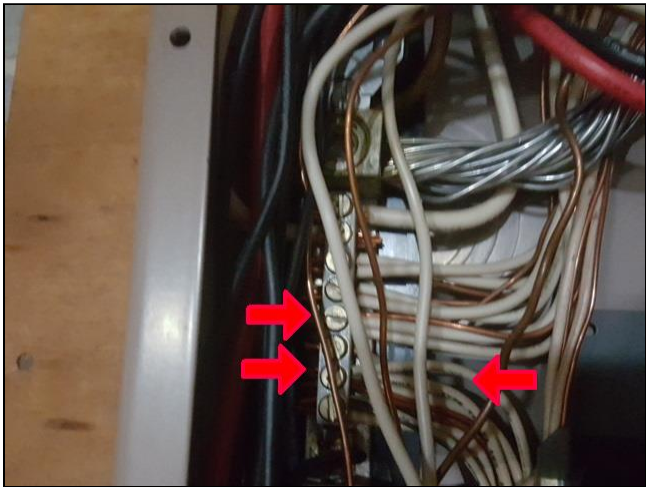
7.1 Item 1(Picture) Multiple Wires

7.1 More than two wires in one lug may dissipate heat inadequately and not allow the breaker to trip. This is considered a safety hazard until repaired. Recommend repair by a qualified electrical contractor.

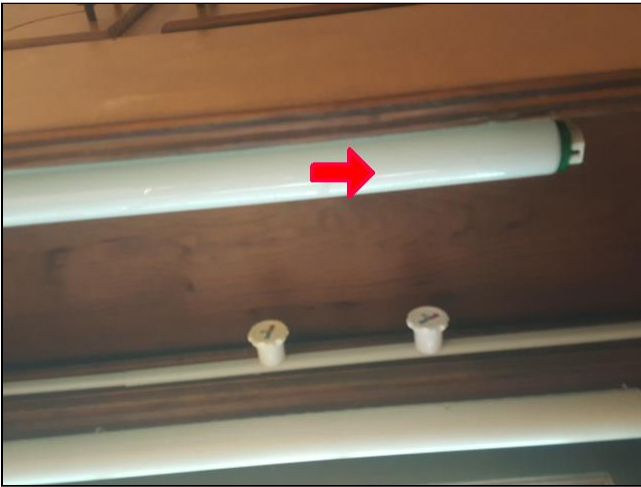
7.3 Item 1(Picture) Not Operational

7.3 Sink light not operational, recommend repair by a qualified contractor

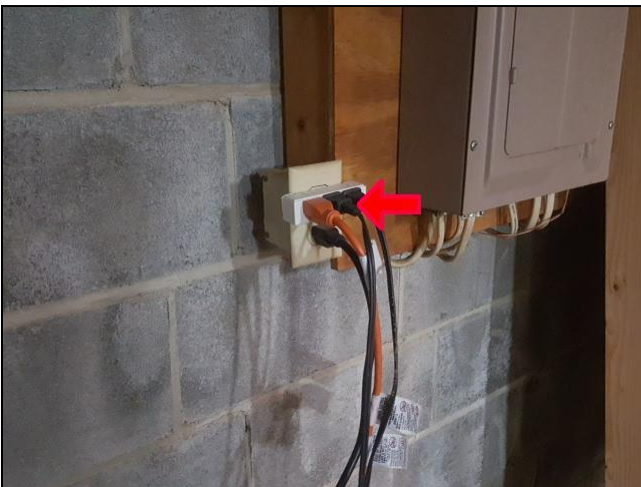
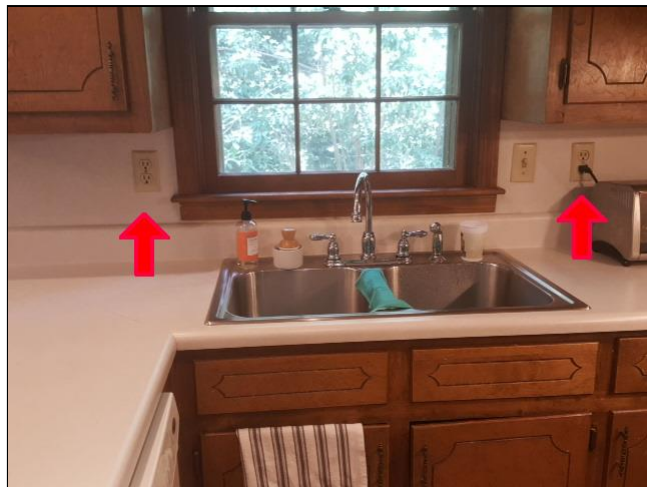
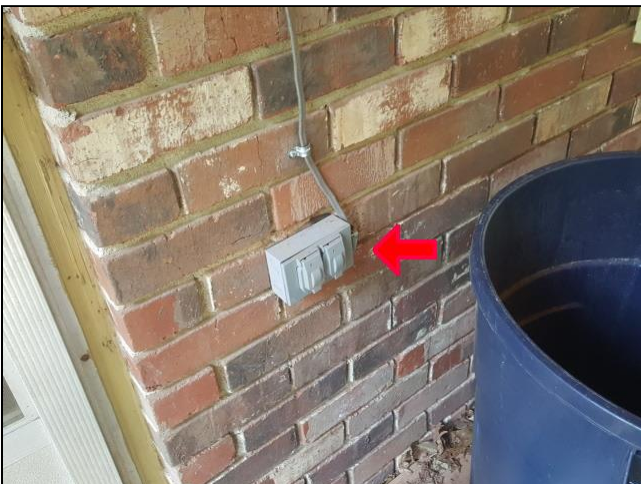
7.4 Item 1(Picture) Not GFCI

7.4 Perhaps not required when house was built but today, GFCI protection is required for outlets within 6 ft of water supply. This includes kitchen countertops, bathrooms, basements, laundry rooms, garages and exterior outlets. Recommend installation by a qualified electrical contractor for safety purposes.

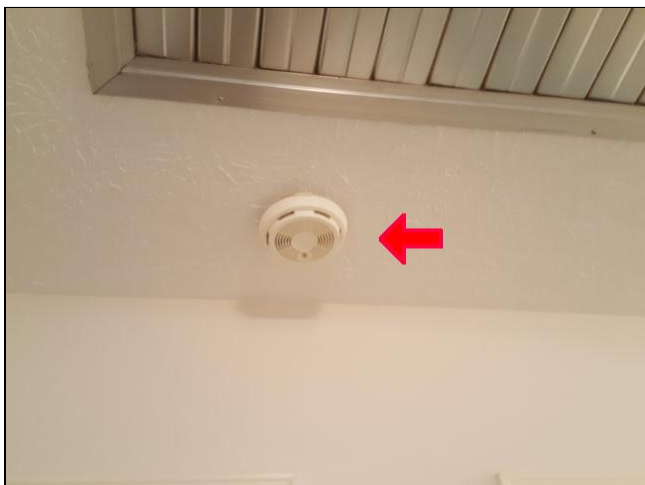
7.7 Item 1(Picture) Not Operational

7.7 Smoke detectors not operational. Recommend repair for fire safety purposes. The design life of a smoke detector is 10 years. Recommend upgrading to photo-electric technology for faster detection response time. Recommend installation by a qualified person.

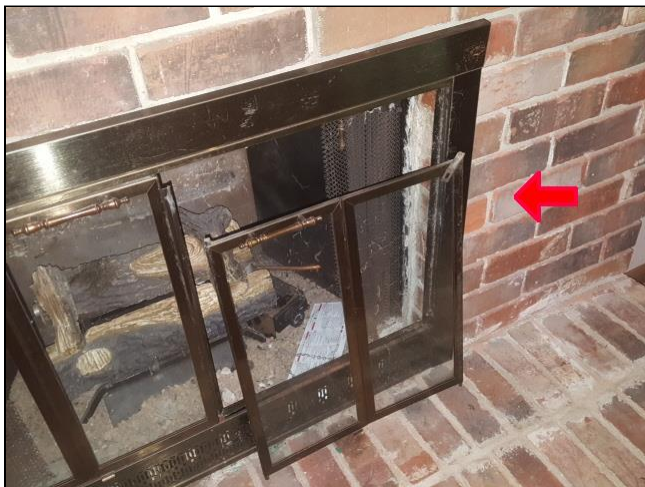
8.6 Item 1(Picture) Detached

8.6 Glass door at chimney detached, recommend repair by a qualified contractor

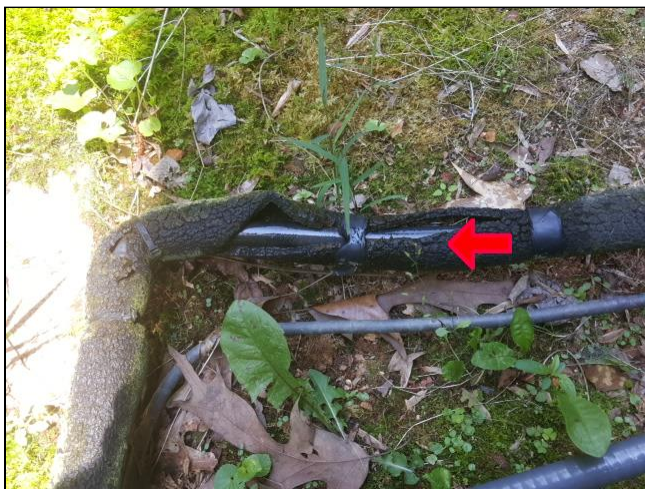
8.7 Item 1(Picture) Tube Deterioration

8.7 (1) The foam sleeve on suction line is missing foam sleeve in area(s) at outside unit. Missing foam on suction line can cause energy loss and condensation. I recommend service or repair as needed.

Cooling system rated fair due to age and absence of service maintenance records. Recommend service and regular maintenance.

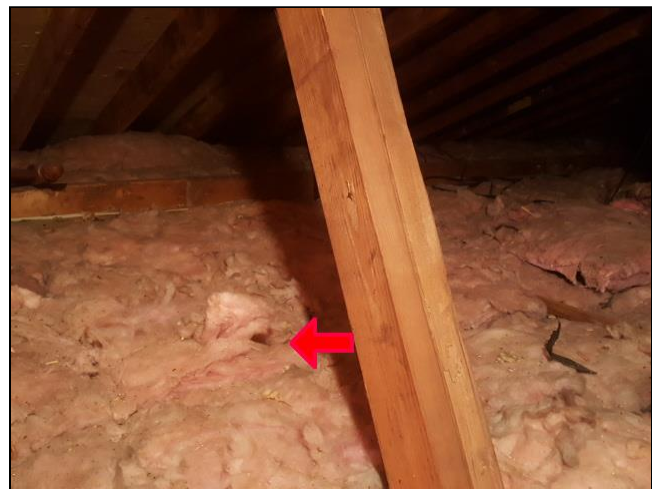
9.0 Item 1(Picture) Trails

9.0 Trails noted at insulation; cannot determine if rodents are active or previous. Recommend evaluation by a qualified technician.

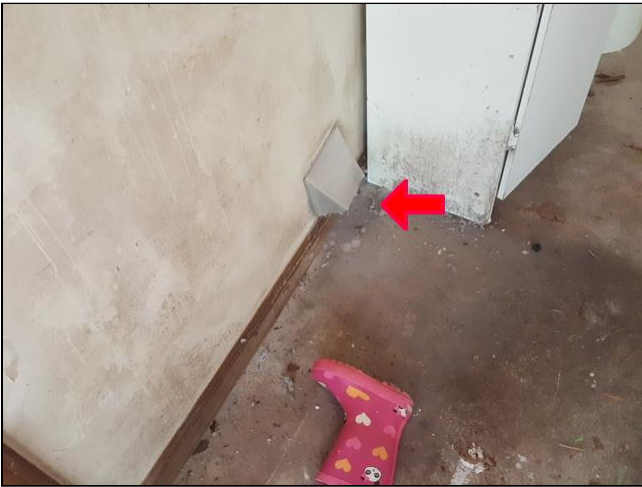
9.2 Item 1(Picture) Dryer Vent

9.2 (1) Dryer vent does not vent to the outside, recommend routing to the outside for moisture control

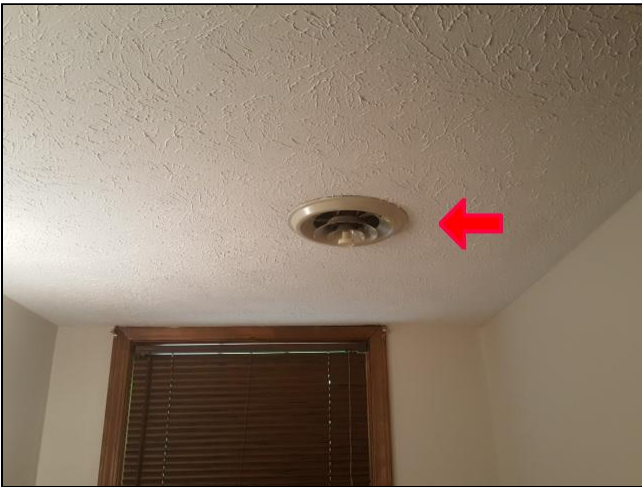
9.2 Item 2(Picture) Not Operational

(2) Vent fan at main level bathroom is not operational, recommend repair by a qualified contractor for moisture control

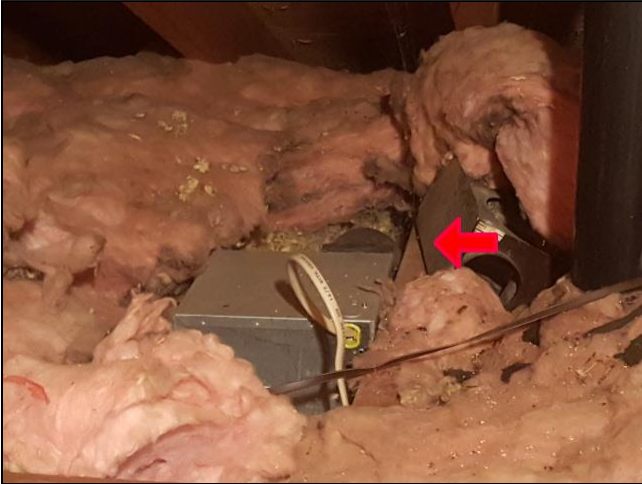
9.2 Item 3(Picture) Vent into Attic

(3) The Exhaust fan does not vent to outside at the upstairs bath. Vent pipes that terminate in attic space can sometimes cause moisture that can lead to mold or cause condensation. A qualified person should repair or replace as needed.

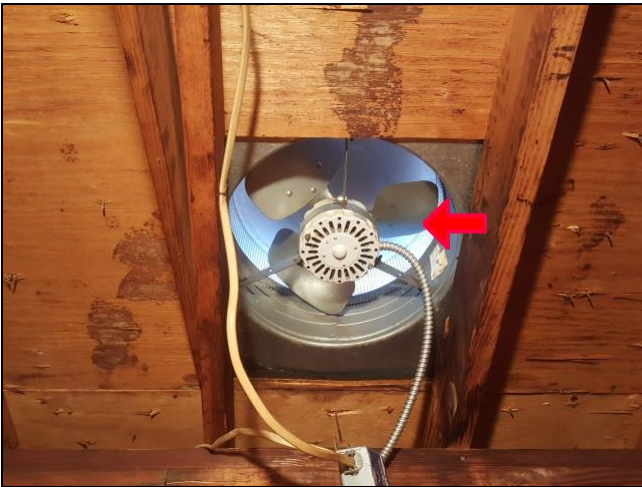
9.3 Item 1(Picture) Not Operational

9.3 Mechanical fan not operational during inspection. A mechanical fan provides adequate ventilation. Recommend repair by a qualified contractor.
